VW '096' AND '01M' STYLE CONVERTERS ISSUES WITH STUD DIMENSIONS

POTENTIALLY AFFECTED PART NUMBERS:
VW17, VW18, VW20, AND VW21

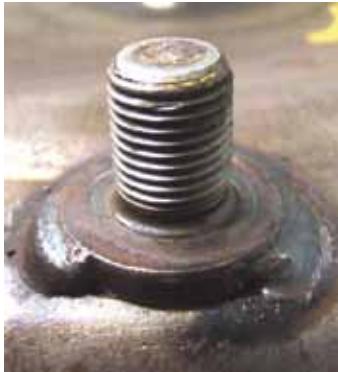
FIG 1.
This stud has threads the full length of the stud.

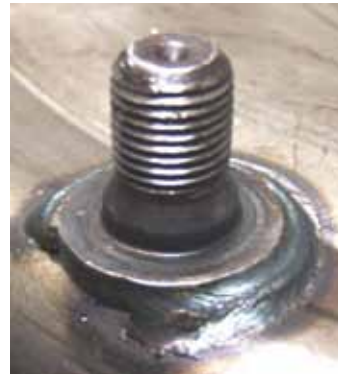
There have been a few cases where customers have reported that remanufactured VW torque converters have studs that prevent the converter from sitting flush against the flexplate. The original core may have studs that have a uniform diameter for the complete length of the stud (fig 1). Replacement converters may have studs with tapered/wider bases (fig 2). If the corresponding hole in the flexplate is not large enough, the increased diameter at the base of the tapered studs will prevent the torque converter from fitting flush against the flexplate.

FIG 2.
Stud with tapered base. Stud does not have threads all the way to the base. Stud flares out to approximately .470" at base.

- If you have purchased a remanufactured VW converter that will not sit flush against the flexplate because of this 'tapered stud' issue, it is recommended that you slightly enlarge the holes in the flexplate. Enlarging the holes to the proper diameter will allow for the proper installation and function of the torque converter.
