# FLANGED IMPELLER HUBS IN 200C / 700R4 AND 4L60/E 10.2" DIAMETER TORQUE CONVERTERS

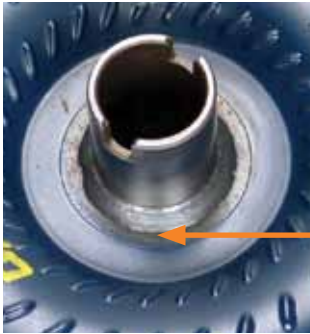
**OE 'NON  
FLANGED' HUB**

OEM 245mm torque converters typically crack at this location

OE torque converters found in General Motors 4X4 and RWD 245mm (10.2") applications have traditionally experienced a high failure rate of cracking at the impeller hub weld. All torque converters use a replacement 'flanged' impeller hub to overcome this problem.
