HONDA TORQUE CONVERTER

H080 FEATURES:

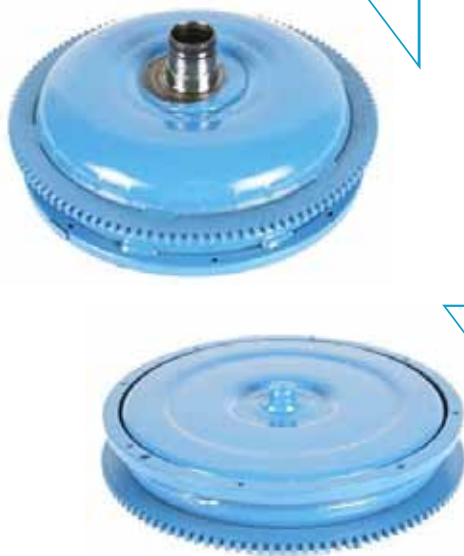
- ▶ OEM piston friction 100% replaced with high carbon paper
 - *Helps to eliminate friction failure*
- ▶ Aluminum stator caps inner diameter is machined larger to allow the cap to expand inward during high heat situations
 - *Helps to keep stator cap from creating metal due to heat expansion*

The torque converter overheats due to transmission hydraulic failures

Installation of one or more of the following transmission repair/update components:

- ▶ S80741P-1 (Sonnax #98892-04K)
 - *Pressure regulator valve*
- ▶ S80741C-1 (Sonnax #98892-06K)
 - *Torque converter check valve*
- ▶ T80168 (Transgo #Honda-LK)
 - *3 Fixes*
- ▶ D30998/D30998A/D30998B
 - *ATF Transmission mounted cooler/warmer*

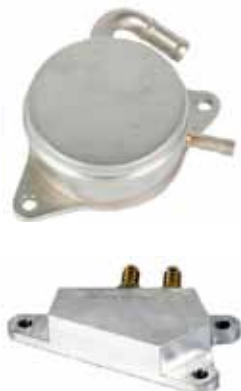
TRANSMISSION MOUNTED COOLER/WARMER

TRANSTAR PART NUMBERS: D30998/D30998A/D30998B
(Depending on make and model)

Also available is an Aftermarket replacement adaptor - A30998U. This adaptor allows the use of a remote cooler to replace the OEM design. This is a good option for warmer climates.

Due to the design of the OEM cooler, flushing is not always the best option.
